DELAWARE RIVER BASIN  
MINE BROOK, MORRIS COUNTY  
NEW JERSEY

MINE HILL RESERVOIR  
DAM  
NJ 00777

PHASE 1 INSPECTION REPORT  
NATIONAL DAM SAFETY PROGRAM

AUGUST 1981

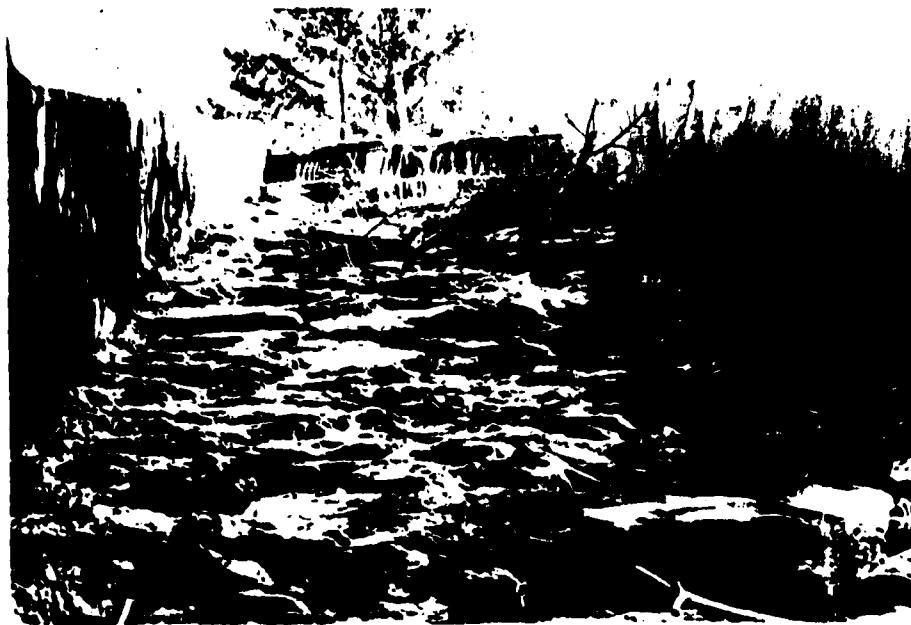
Debris and trees in upper portion. Both sides are cracked and spalled. Continuous undermining of concrete walls at base. Bottom of channel placed stone - water is entering bottom of channel and exiting below spillway.

View looking u/s in spillway channel.

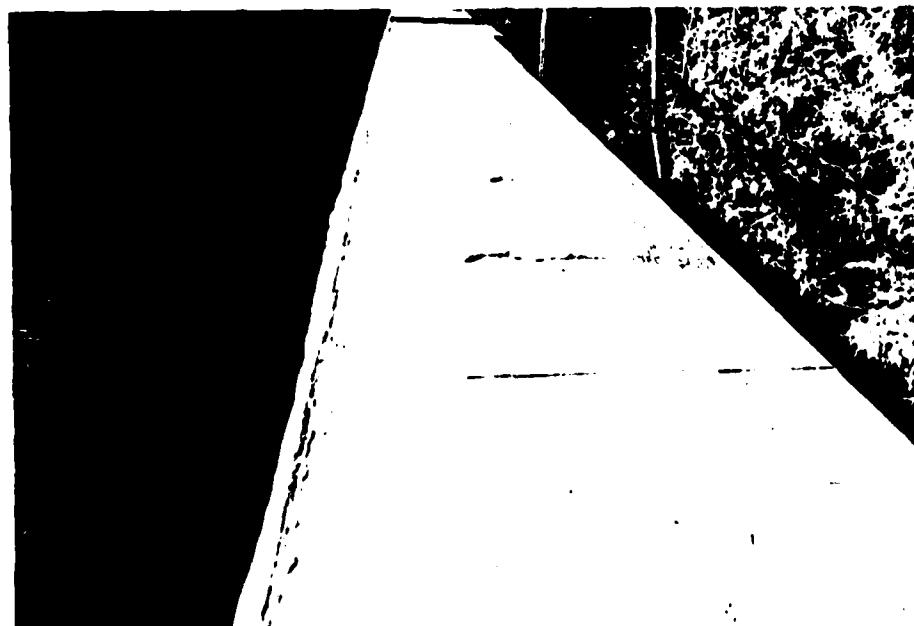
Looking along axis of dam crest from the right (north).
